Marshes with and without sills protect estuarine shorelines from erosion better than bulkheads during a Category 1 hurricane

Rachel K. Gittman [a, *], Alyssa M. Popowich [a, 1], John F. Bruno [b], Charles H. Peterson [a, b]

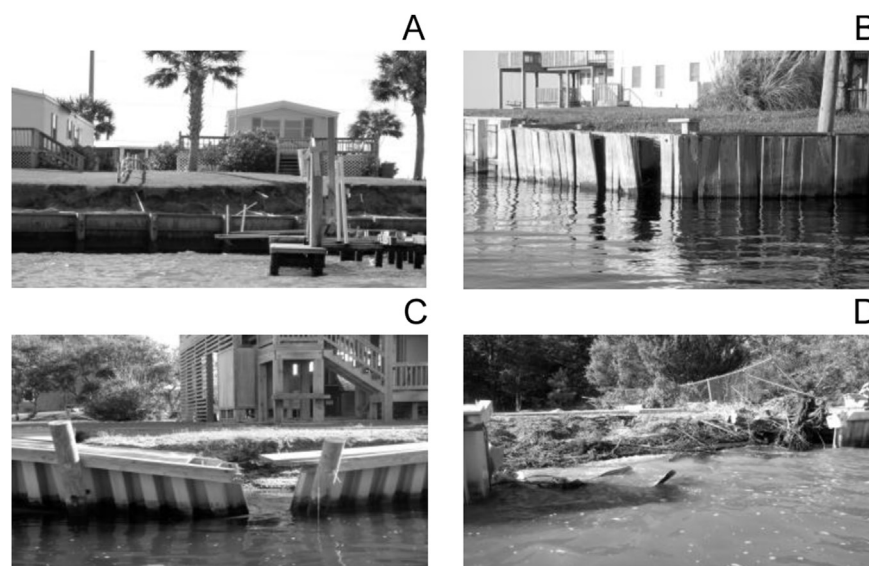
erosion of the shoreline landward of the structure (Fig. 3A). Structural damage was defined as warping or evident damage to the structure without breach or collapse (Fig. 3B). A breach was defined as a gap or hole visible in the structure that allowed landward sediment to escape (Fig. 3C), while a collapse was defined as complete loss of the integrity of the structure so that it was no longer effectively retaining any sediment landward (Fig. 3D). Photographs were taken of each shoreline protection type (e.g., bulkhead, riprap revetment, sill) and each instance of damage to a shoreline protection structure. GPS data were imported into ArcGIS as shapefiles. Shapefiles were overlaid on 2010 aerial orthoimagery (North Carolina One Map, 2013) and digitized shorelines of Bogue Banks and the Outer Banks (NC DCM, 2012). NC DCM classified NC shorelines using 2007 aerial orthoimagery for Dare and Hyde counties and 2010 aerial orthoimagery for Carteret County (where Bogue Banks is located), producing ArcGIS continuous line shapefiles that include the shoreline type (marsh, beach, modified with structure [hardened]) and shoreline structure type (boat ramp, bulkhead, bulkhead and riprap combined, breakwater, groin/jetty, sill, riprap revetment).

Fig. 3. Bulkhead damage classifications: A) Landward erosion; B) Structural damage; C) Breach; and D) Collapse.

Of the 1.86 km of bulkheads surveyed in Rodanthe, Waves, and Salvo (Fig. 4A), 76% (1.41 km) was damaged after the Hurricane (Fig. 4B), with damage ranging from landward soil erosion (Fig. 3A) to complete bulkhead collapse (Fig. 3D). In contrast, only 4% (0.26 km) of the 7 km of bulkheads surveyed in Frisco, 9% (0.83 km) of the 9 km of bulkheads in Hatteras Village, and 12% (1.14 km) of the 9.77 km of bulkheads on Bogue Banks (Fig. 4A) was damaged (Fig. 4B). No visible damage (structural failure, landward soil erosion) was detected to sill, riprap revetment, or hybrid shoreline structures surveyed within the study regions.
